Pbar Note #699

DRF1 Cavity Power Amplifier Repair

R J Vargo
9/07/2005

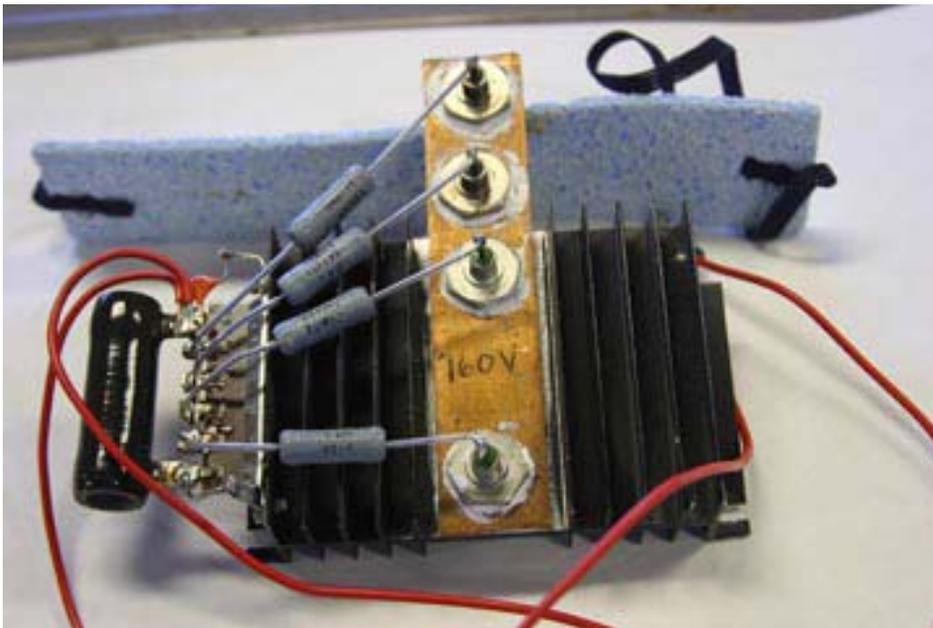
(2) Bias zener diode(s) stack open.

Yes, it does happen. AND it will happen again. This failure will not have a catastrophic symptom. Instead, you will find that the cavity output is low. This is easily confused with weak output tubes NOT ALWAYS TRUE. Since the tubes are with no clamping from the zener stack they will go deeper into self cutoff during the drive pulse. This inhibits the output from fully appearing at the plates. The bias supply will show the correct voltage (~155V) on the front panel meter and all other appearance will seem to be correct. Watch out for this one! A way to test this is to use an ohm meter with the Negative lead at the bias input. This should read as a normal diode. Remember that there are a number of parallel components (resistors and large capacitors) so refer to the drawing for a clear understanding of its electrical environment.

Zener Diode Stack
Located within the top half of PA

Replacements for the zener stack are located in AP50 on the accumulator side in a cabinet facing the walkway to the counting room. Refer to the picture in the back of this note for the zener assembly identifying features.
