MIDWEST MATERIALS AND ENGINEERING CONSULTANTS, INC.
BARTLETT, ILLINOIS
312/830-4979

FERMILAB

FAILURE ANALYSIS OF TEV I ELECTRODE (TIE) ARRAY SOLDER JOINTS

September 2, 1987

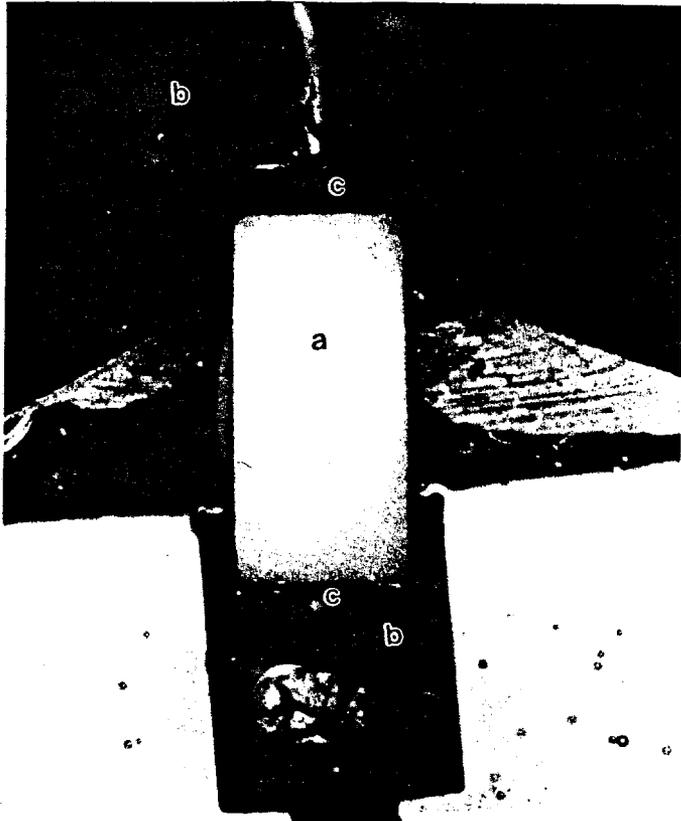
Figure 7a: Cross section of a resistor assembly.

Weep holes within the BeCu housing permitted flux and air to outgas, maximizing solder coverage.

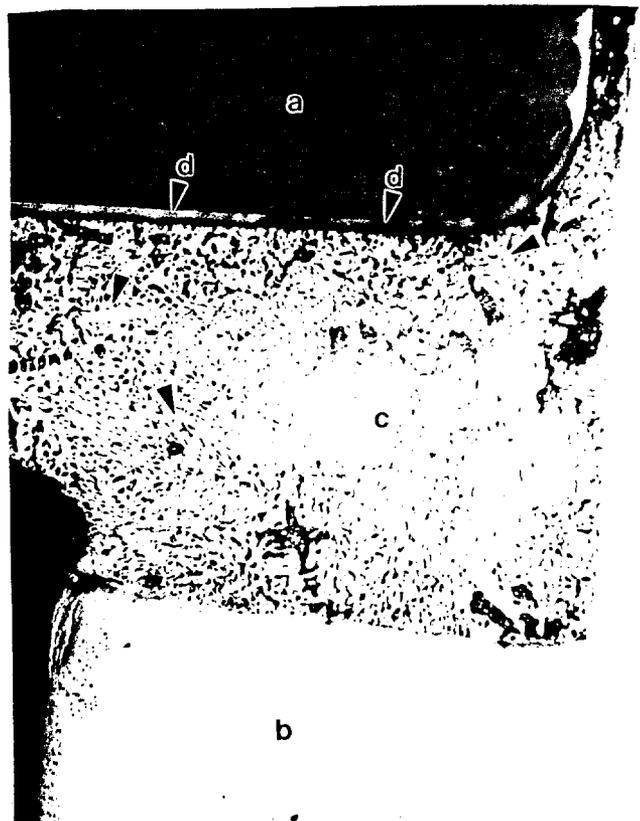
Figure 7b: Resistor solder joint X100. Arrows indicate gold-tin intermetallics.
