**Pbar Target Station**  
Target and Beam Sweeping  
High Gradient Lithium Lens

Jim Morgan

DOE Review

February 25, 2003

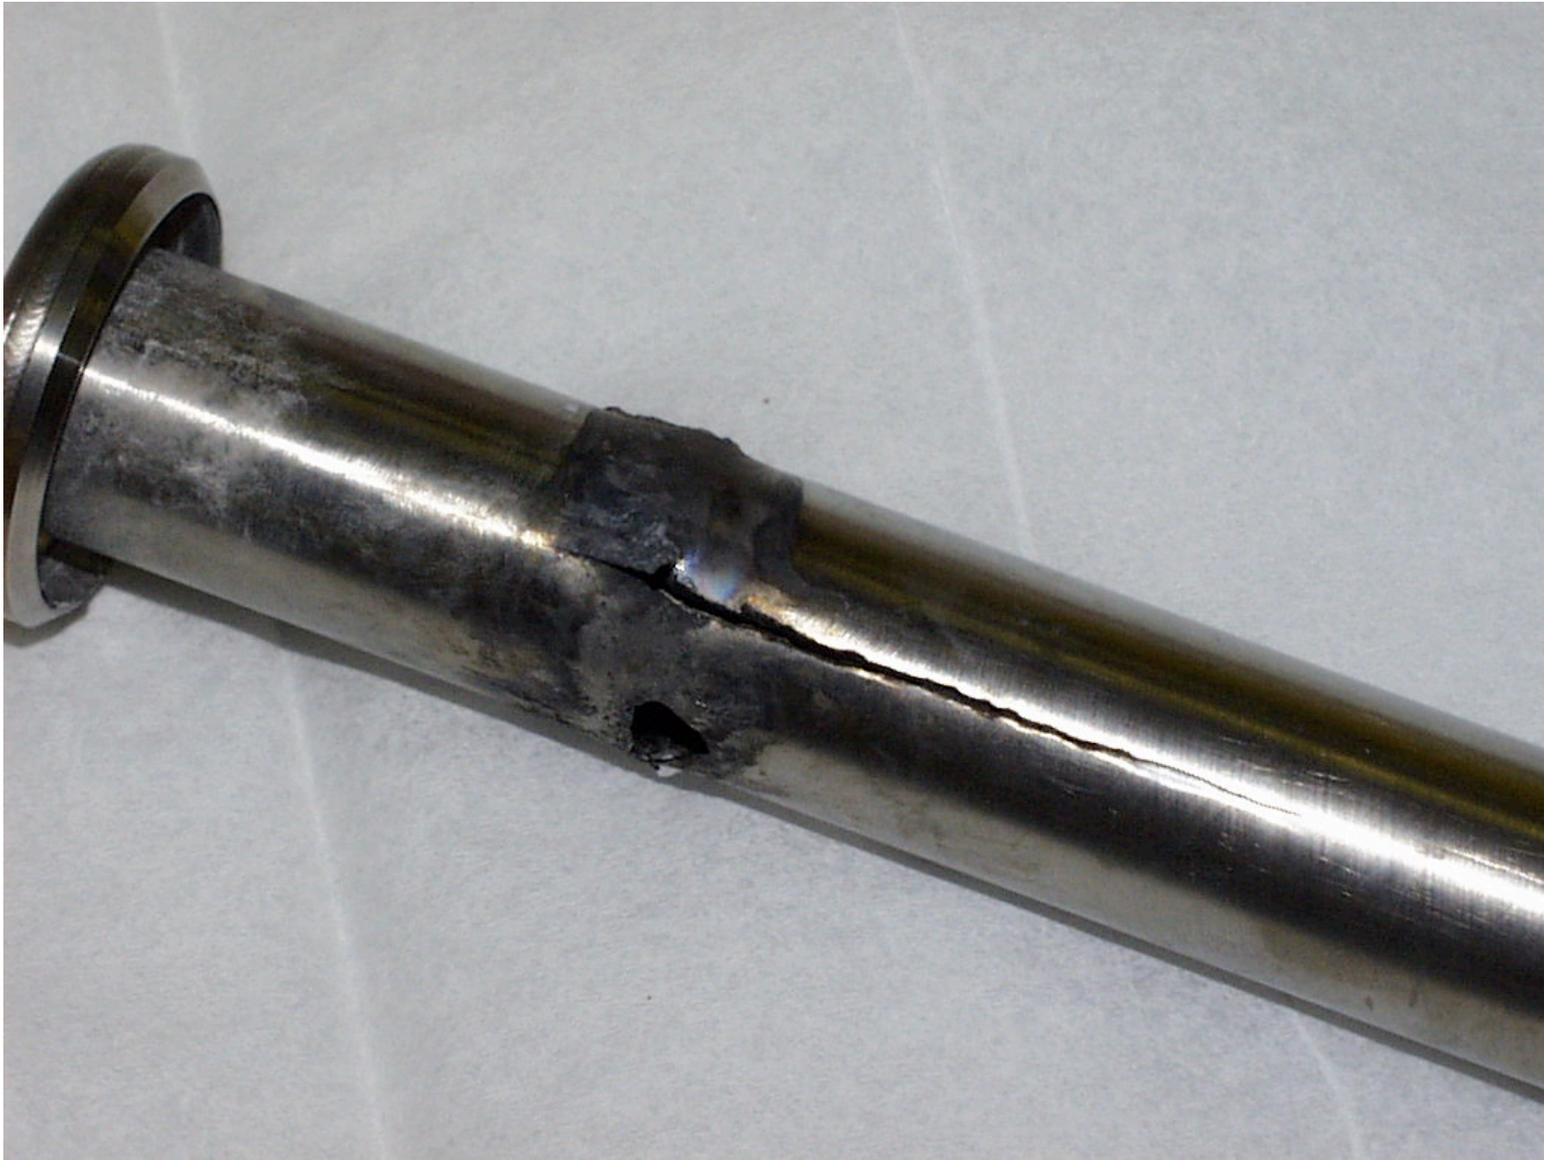
## Lens #21, outside of inner septum

- Progress of Lens disassembly and analysis
  - Lenses 20, 21, and 26 have been finished
  - Lenses 16, 17 and 18 have been examined
    - Lens 16 had a high pulse count, but no septum breach
  - Lens 22 has been disassembled and analyzed
    - Only weld failure out of autopsied lenses
- General Results of Analysis
  - Axial intergranular fracture followed by ductile fracture
    - Intergranular nature of crack more consistent with corrosion
    - Length of remaining tube wall prior to ductile fracture consistent with lower loads from ANSYS
  - Circumferential channels burned through some septum
    - Suggests internal arcing, possibly from Li/Ti separation
    - Small cracks may be obliterated after arcing begins
  - Multiple micro-cracks and pits found on the inside

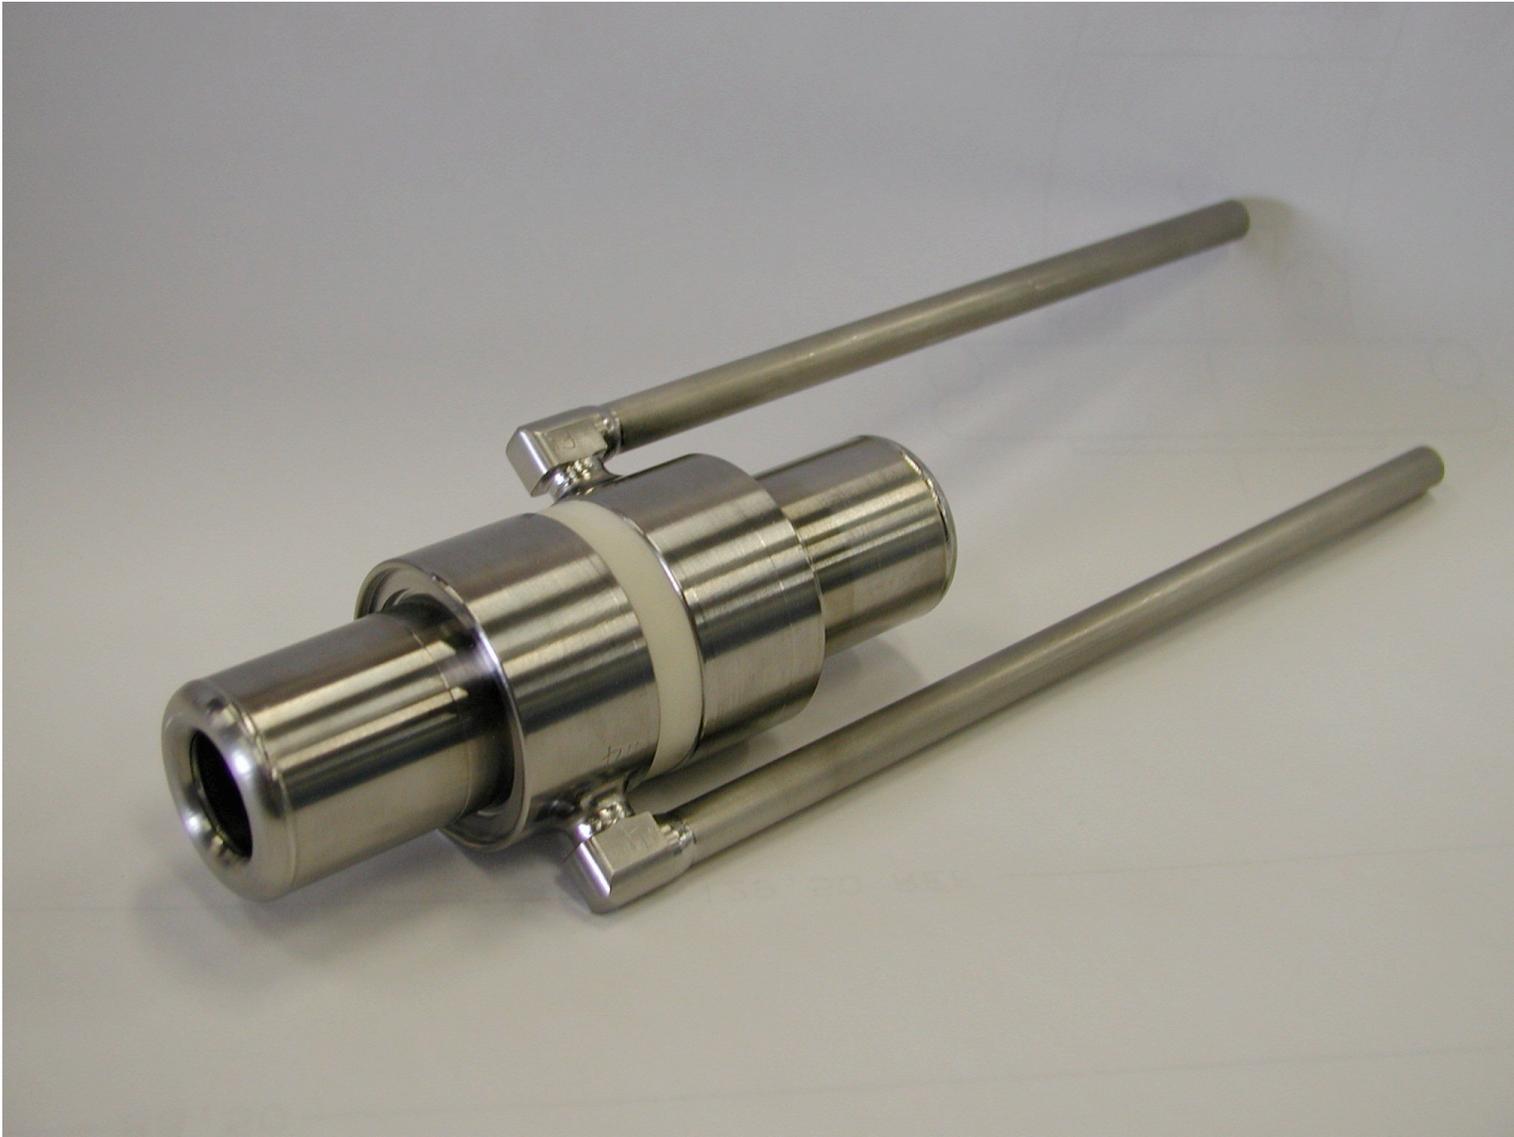
## Complete lens septum assembly
