MIDWEST MATERIALS AND ENGINEERING CONSULTANTS, INC.
BARTLETT, ILLINOIS
312/830-4979

FERMILAB

FAILURE ANALYSIS OF TEV I ELECTRODE (TIE) ARRAY SOLDER JOINTS

September 2, 1987

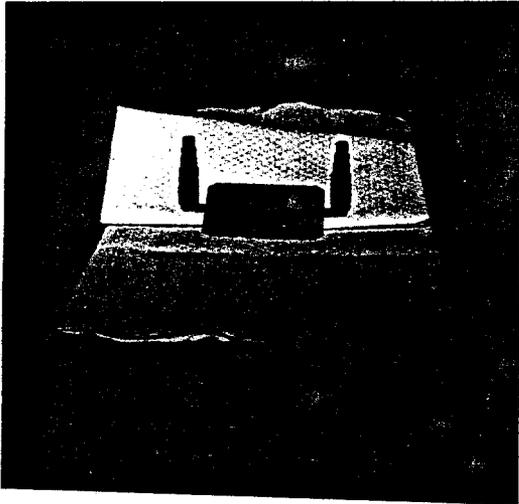
The loop assembly samples were reportedly from standard production runs, which involved the attachment of an OFHC Copper post via Sn 62 solder with RMA flux to a Beryllium Copper plate. The solder joint has a ring-and-plug type of configuration, figure 1. Samples evaluated were as-soldered and from disassembled cooling tanks that had experienced approximately 2 years of service.

Figure 1: Documentary photograph of a soldered loop assembly. The plate is beryllium copper and the posts are OFHC copper. The solder joint configuration is ring-and-plug.

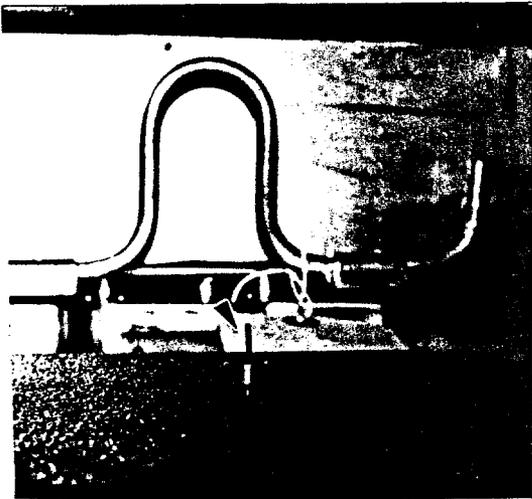
The resistor assemblies were also standard production. This involved the attachment of a small, reportedly carbon composition resistor via Sn 62 to the beryllium copper housing. The terminations of the resistor were gold plated over their metallization. The solder joint has a cup-and-plug configuration, figure 2. Samples evaluated were from the same disassembled cooling tanks as the loop assemblies.

Figure 2: Documentary photograph of a resistor assembly. The housing is beryllium copper and the resistor has gold plated terminations. All solder joints evaluated were made with Sn 62.
