Pbar Note 542

Reliability of the Fermilab Antiproton Source

E. Harms, Jr.
Fermi National Accelerator Laboratory*
P. O. Box 500, Batavia, IL 60510 USA

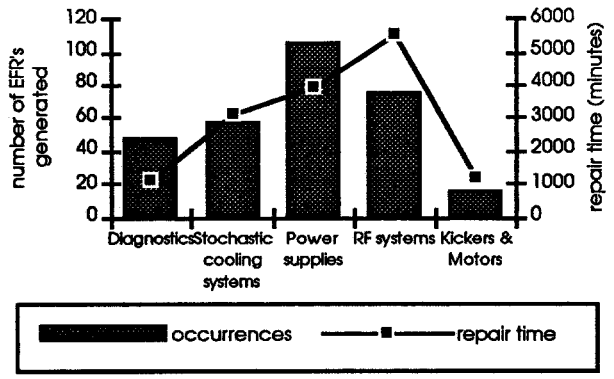
Figure 1
Summary of FNAL Pbar source
Equipment Failure Reports

Another reliability indicator is Equipment Failure Reports (EFR's). EFR's are written reports filled out by technicians making repairs to or replacing faulty components. The Pbar EFR system in its current configuration has been in place since May 1990 [3]. EFR's are filled out only on components which fail during normal operating periods; repairs and replacements made during extended scheduled maintenance periods are not so documented. Figure 1 is a summary of EFR data.

In general, three classes of power supplies are used to excite Pbar source rings and beam line magnets: those with output less than 1 kW for dipole correctors, those with output in the 1 to 80 kW range for beam transport elements and ring quadrupoles and sextupoles, and those with output more than 1 MW for ring dipoles and major beam line dipole strings. The low power supplies contribute the second leading number of incidents, yet the least amount of repair time because these supplies are more often replaced rather than repaired in the field. The middle class has the most failures, though problems usually lie with instrumentation or metering rather than actual internal problems. Devices comprising the third class, while having the fewest failures, generally take the longest time to repair. A fourth class of devices, shunts for fine control of individual elements in series strings of dipoles or quadrupoles, have their share of failures as well.

The Accumulator and Debuncher each contains three radiofrequency systems. DRF1, the Debuncher 53 MHz bunch rotation and debunching system, has generated the greatest number of EFR's in the RF system category. This is primarily due to the larger number of components in this system than in the five others. DRF1 is comprised of eight cavities generating up to 1 MV each while the five other RF systems combined total six cavities generating substantially less voltage with a lower duty factor.

Traveling Wave Tube (TWT) power supplies dominate the Stochastic Cooling generated EFR's. Seventy-five such supplies drive the final stage of amplification of the stochastic cooling kickers for the nine cooling system used in the Antiproton source. No single mode of failure dominates [4].

Microprocessor-based scanners for the beam line Secondary Emission Monitor (SEM) grids are the most troublesome diagnostics component. Many of these devices are installed in the beam line enclosures and

are sensitive to the radiation found in those areas. Some scanners, specifically those in the 120 GeV line from the Main Ring to the target station and near the major bends in the injection and extraction lines, have been moved to the quieter environment of adjacent service buildings. The rate of failure of devices so moved has dropped significantly. Additional scanners will be moved out of the tunnels as resources permit.

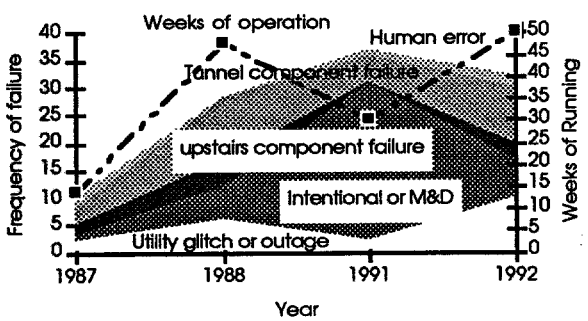
Figure 2
Summary of Dumped Stacks 1987 to present

A third measure of reliability is the frequency of loss of particles stored in the Accumulator, known colloquially as 'dumping a stack'. Figure 2 summarizes the frequency and reasons for dumped stacks over the history of the Pbar source. On average, a stack is dumped once per two weeks of operation. The longest sustained stack was 39.4 days achieved during November and December of 1988.

Dumped stack data from 1991 is unique in that the Accumulator was used as an experimental area for E760. A typical week consisted of 42 hours of antiproton stacking, 92 hours of data taking and time for experimental set up and scattered downtime. Since most stores required decelerating the antiproton beam to an energy less than the accumulation energy of 8 GeV, what was left of the stack at the end of a store was dumped, an access made if necessary, then the Accumulator turned back on for antiproton stacking. Fewer component failures were encountered due to less stacking time per week compared to Collider operation and because unneeded loads were turned off once set up for a store was begun.

Over the history of the Pbar source, most dumped stacks have been due to failure of a component in the Debuncher/Accumulator tunnel. Failure of a pulsed septum or kicker magnet module was the culprit in thirteen of the twenty-nine such cases.

Utility glitches or outages have contributed twenty instances. Most such losses are traceable to glitches on the transmission grid of the electricity utility supplying Fermilab.

Only a handful of dumped stacks can be attributed to human error.
